CITY OF VIRGINIA BEACH

# Croatan Beach Informational Briefing

LJ Hansen, Dan Adams | March 28, 2023

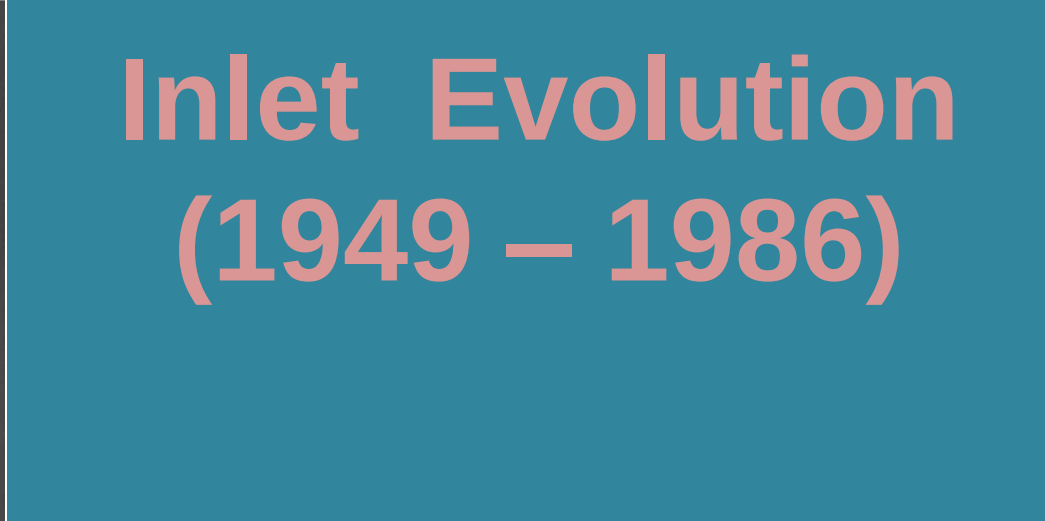
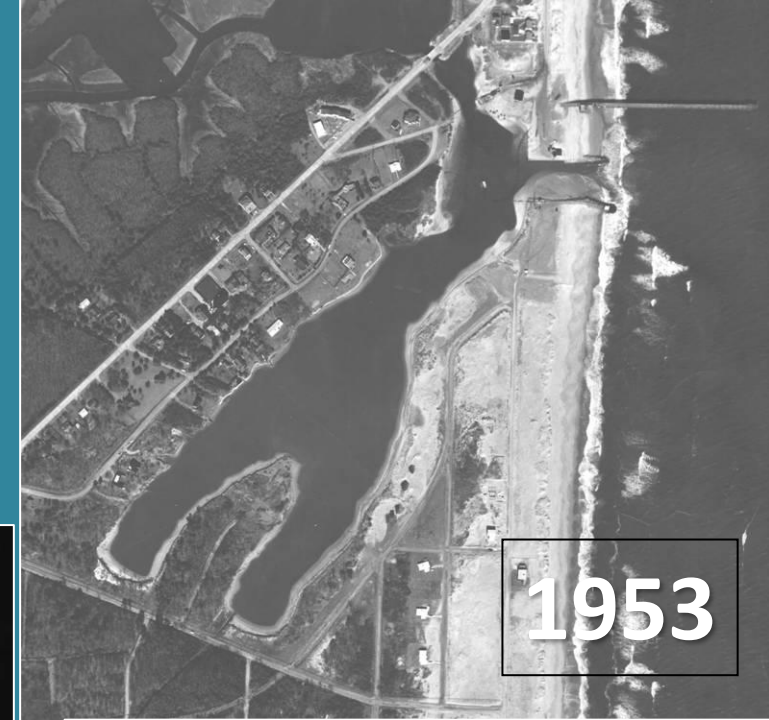
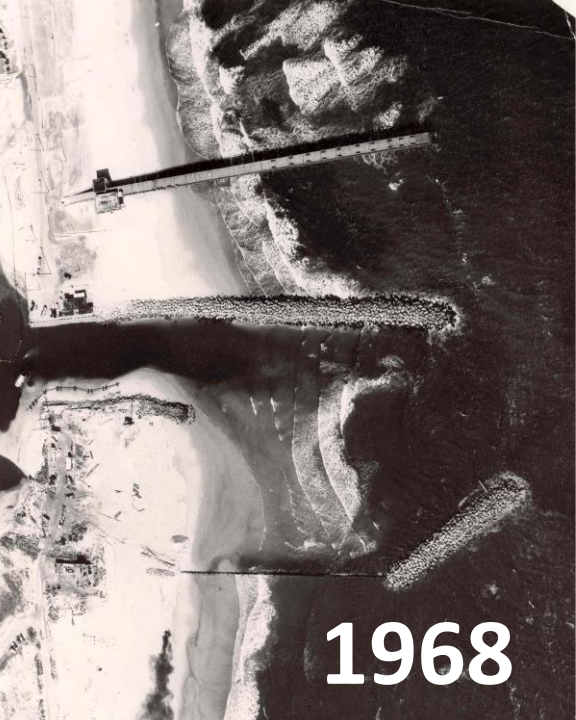
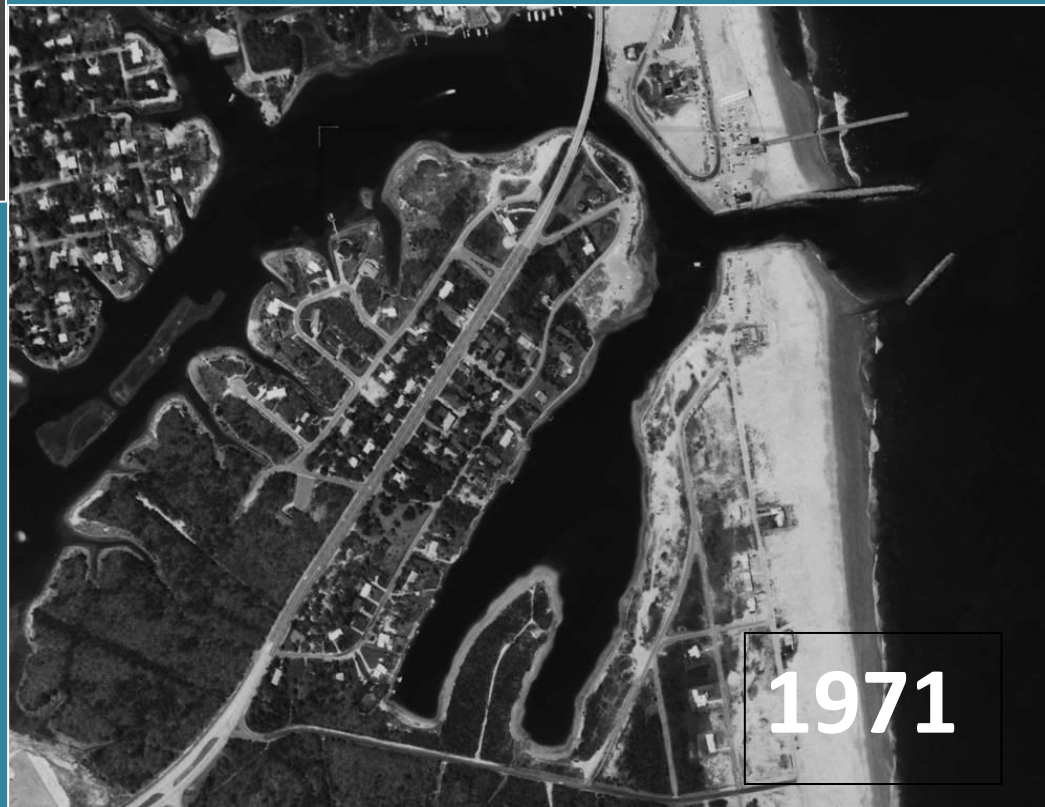
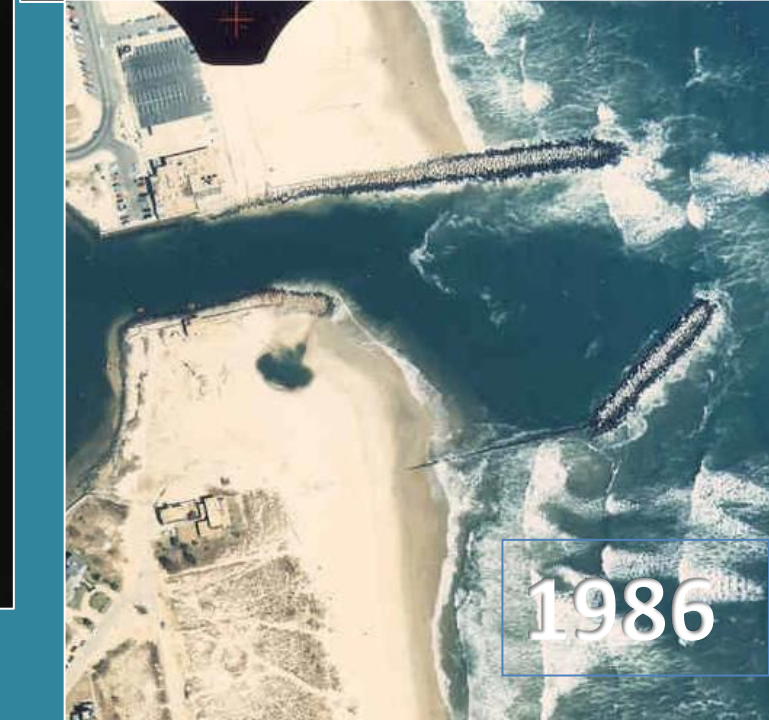
# Inlet Evolution (1949 – 1986)

1949

1953

1968

1971

1986

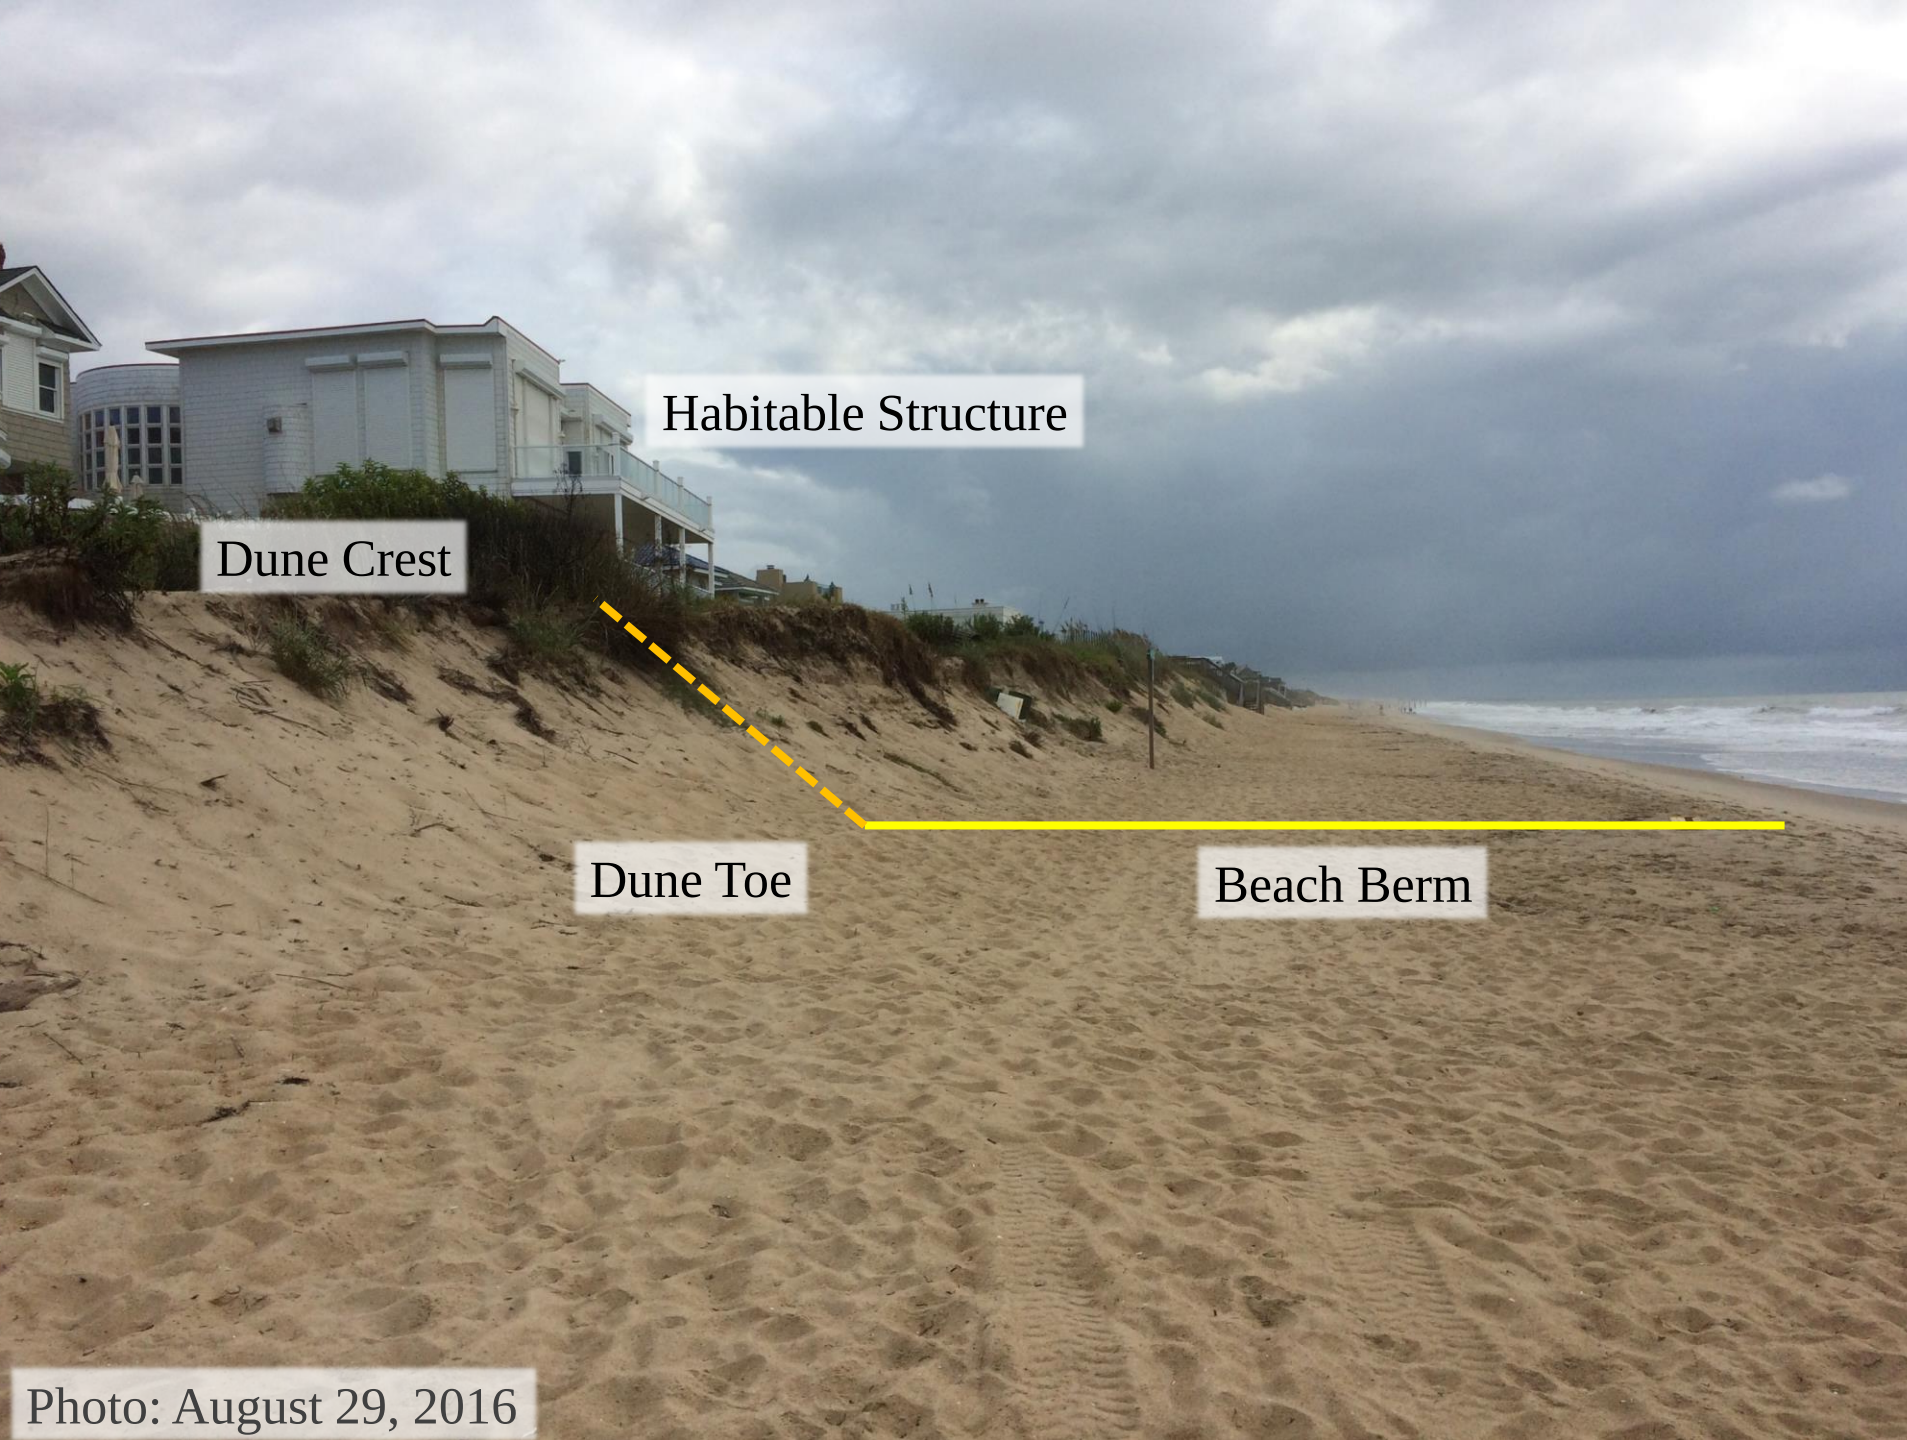
Photo: August 29, 2016

## Definitions

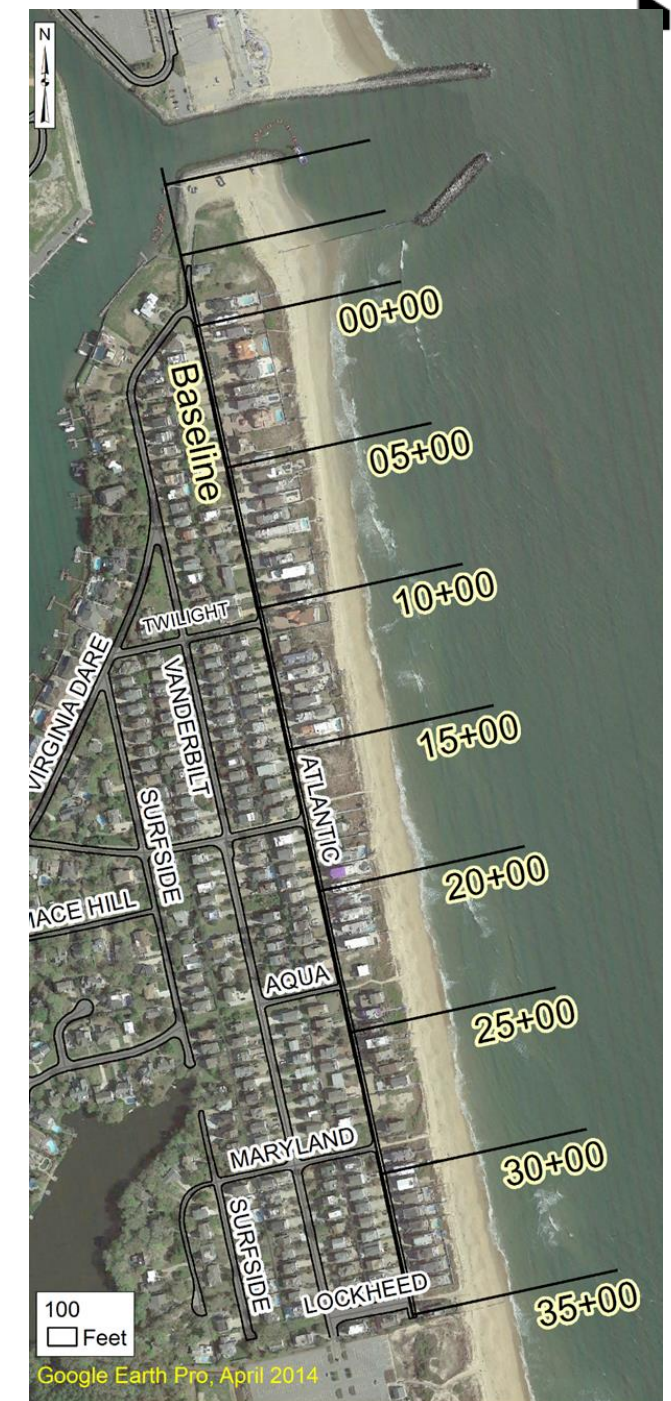
- The study was done mainly using the November 2015 post-storm survey profiles
- August 2016 site visit and survey indicate profile is eroded landward of November 2015
- A conceptual plan is needed to restore / maintain dune height and volume at stations 05+00, 10+00, and possibly 15+00
- Meeting the community's beach width criteria will require construction of a beach berm, in addition to the dune restoration above

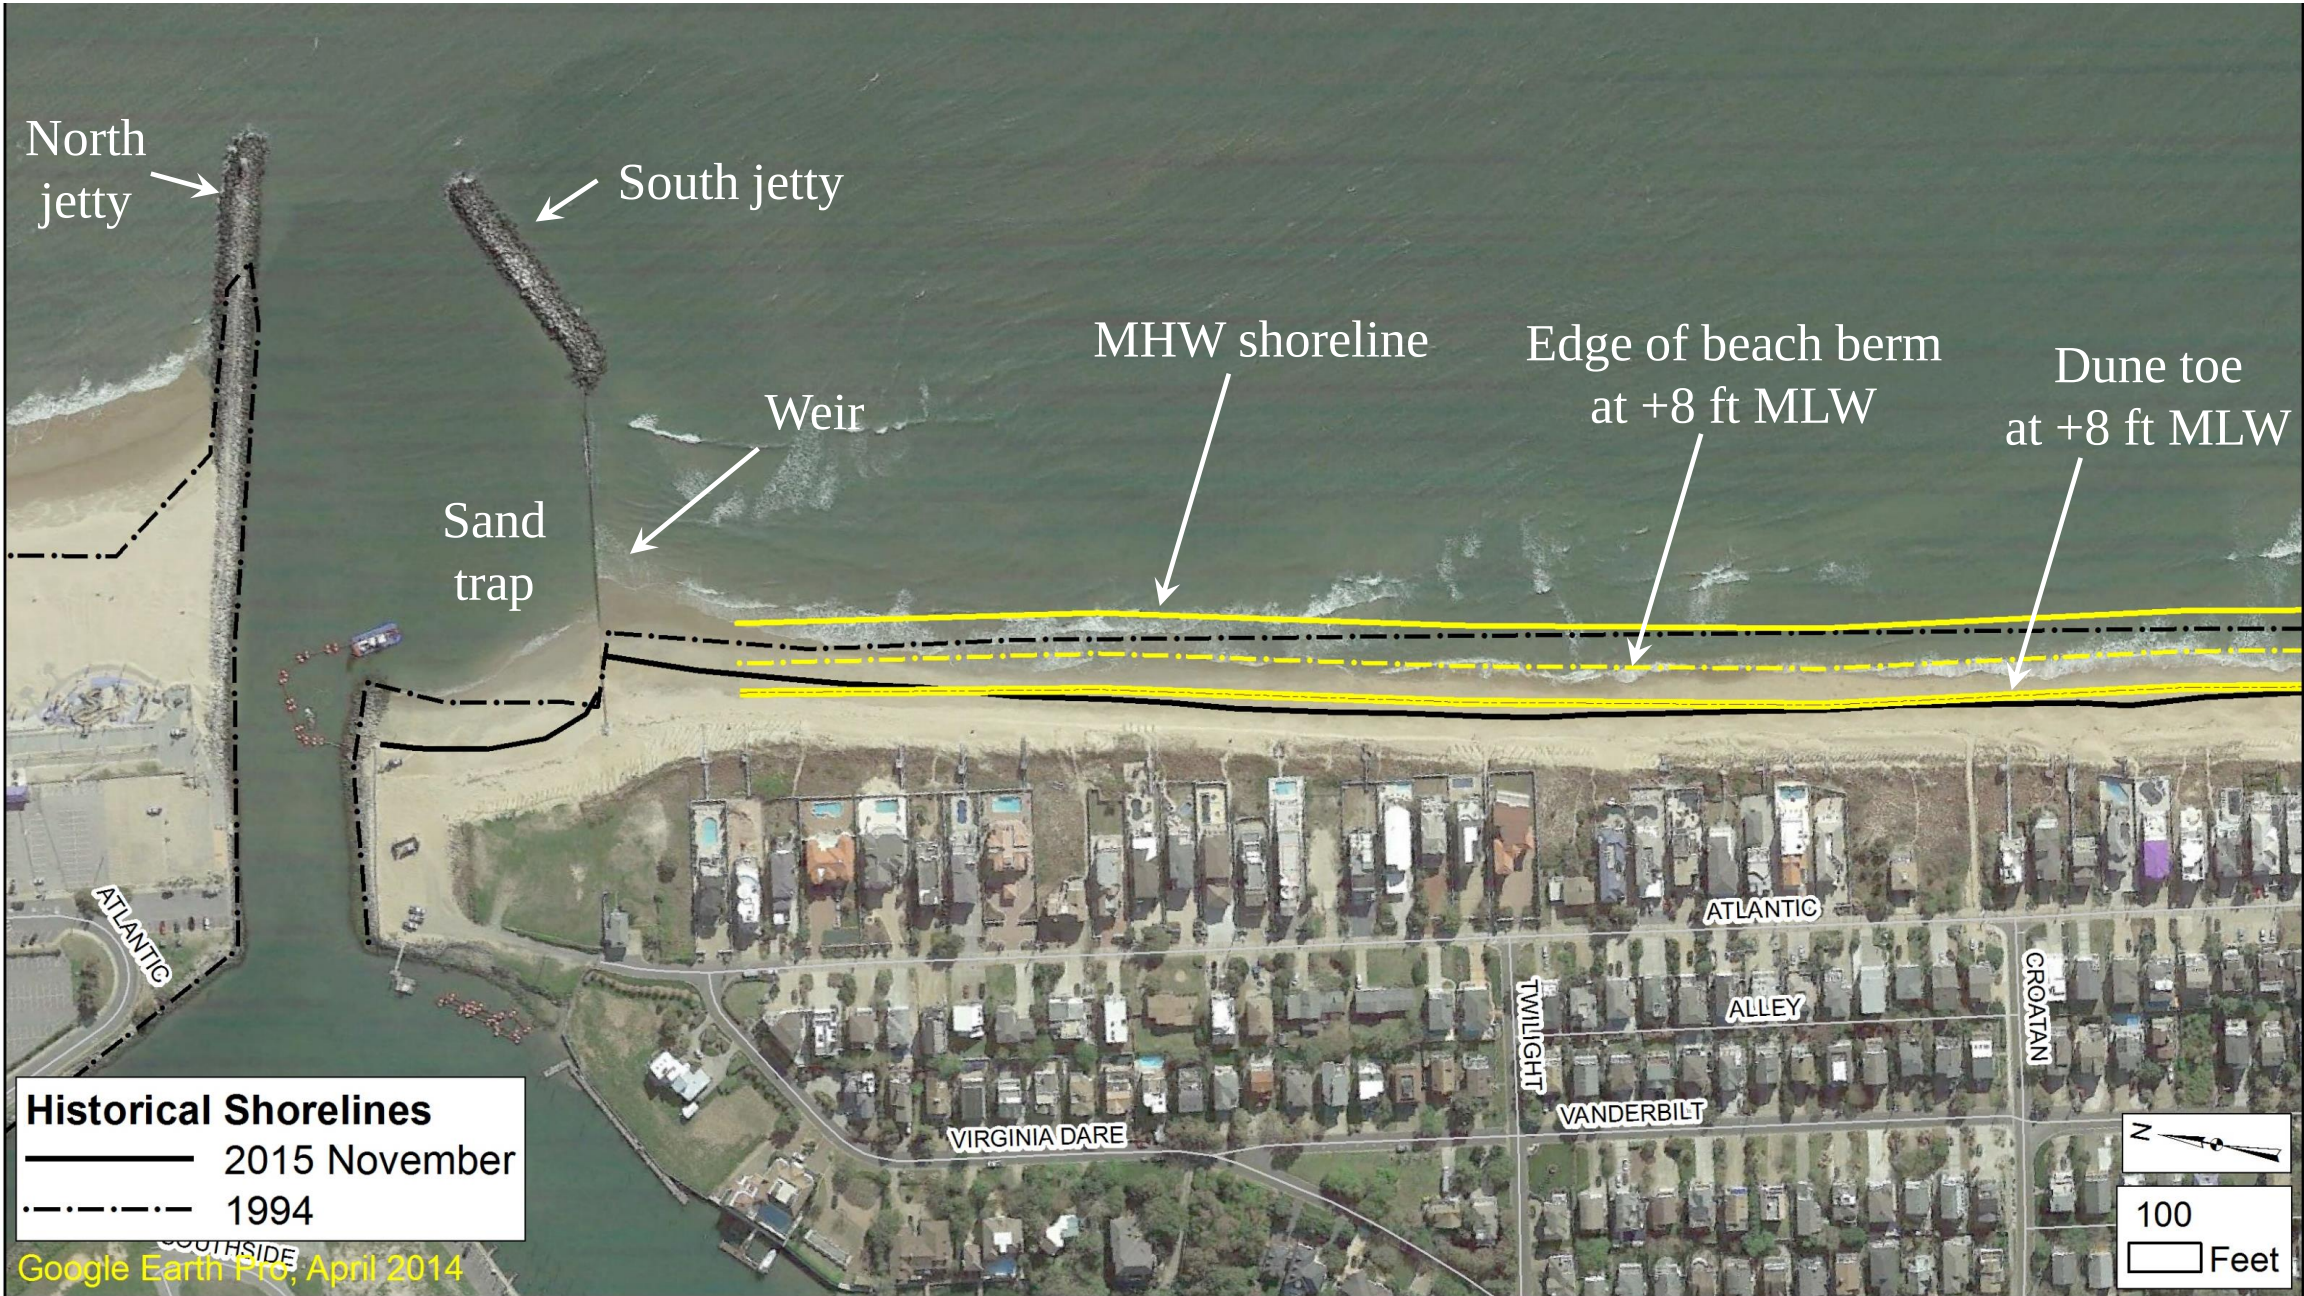
# Conceptual Design to Restore Dune and Increase Beach Width

- Developed an outline design for
  - restoring dune volume, and
  - increasing beach width
- The plan creates 50 feet of flat beach berm between a dune toe at +8 feet MLW and the seaward edge of the berm.
  - 40 feet of berm adjacent to the weir
- The total beach width between the toe of the dune and the MHW shoreline varies between 100 and 120 feet.
- Requires approximately 130,000 cubic yards for initial construction
  - 20,000 annually should be sufficient for maintenance in “average” years
